An Investigation on Shifting and Subsidence of Right Embankment of Devee River at Bauriakana, Puri District of Odisha

Gopal Prasad Roy

Anil Kumar Kar

Kabir Mohan Sethy

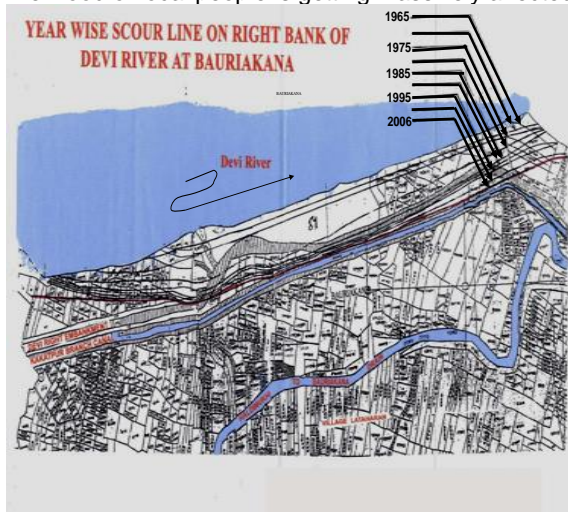
Fig. No.2. Scour line of right embankment and huge agricultural land at right bank of study area

As evident from local information and satellite imageries that the river Devee is gradually shifting to right side. Since 1955 the right embankment shifted so many times spoiling acres of land and the present position of the embankment is settled only after 2008 flood.

In the process it has engulfed nearly 1 km of precious land over a longer patch. Thus a huge population is affected at right side and on the reverse the left side is getting a large sand deposit. The river gradually drifts from left embankment. The figure (Fig.2) below shows the process of river shifting from 1965 to 2006. Due to huge loss of agricultural land the livelihood of local people is getting massively affected.

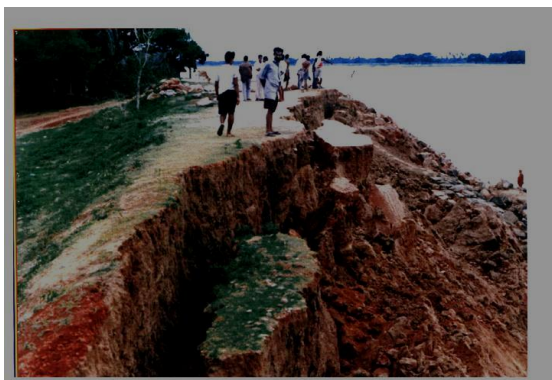
Fig.No. 4. Embankment Subsidence during 2008

Adding to this another difficulty lies in the right embankment is that a constant subsidence at a particular location during post flood period which also accelerates the shifting of bank. Regarding this we have collected much previous information and found the claim correct (Fig.4).

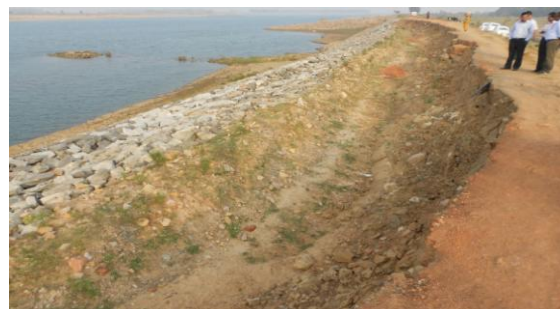
Fig.No.5. Subsidence of Right Embankment

The mark of subsidence is seen in right embankment. The subsidence shown in Fig.5 is the result after release of flood water of 2014. The tidal effect is well marked as understood from local inquiry and the site is around 10 km upstream from Bay of Bengal. It is also evident from local inquiry that the sand cast which is seen at left side of the river is getting created only 20 years back. Few also told a branch of river/ nullah was releasing from the main river near spur 9-11 and the present embankment is made over that, which promotes subsidence. Another feature was evident that no subsidence occurs during flood but it happens only when the flood water recedes.

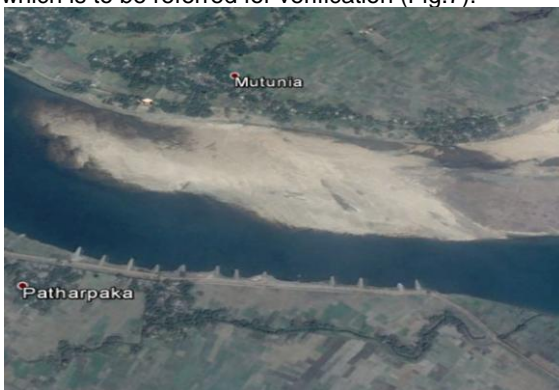
Fig.No.8. The spur locations and probable effect of currents at right embankment (source: google earth)

As the team found there are 14 spurs to deflect the current still the damage existing although minimized. So after investigating the site and local inquiry the adequacy of spurs as well as the location was under question. The main strike of current is at spur 9-11. The role of other spurs is to gradually moderate the flow and deflecting is also needs verification from the water resources department. Another, the dimension of the spurs for the hydrodynamic design also plays very important role, which is to be referred for verification (Fig.7).

The meandering characteristics start from spur 1. So at least one physical modeling can be tested for dimension and location of spur1. The investigation for existence of a branch channel must be continued through tests like Undisturbed Soil Sample (UDS), electrical resistivity tomography (ERT) This study is in support of the IIT Chennai Report regarding the inadequacy of the number of Spurs and also recommends for quick repair of the damaged Spurs.

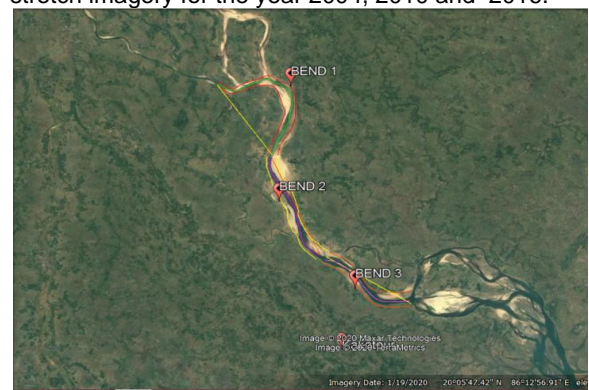
Fig. No.9. Showing bends at upstream of study area

In lieu of satellite imageries the freely available google earth image at different period is considered and the beginning of the bend just before the target spot at Bauriakana. On physical verification of site it was decided to divide the upstream of target length into 3 parts as shown in Fig.8 and the morphological values are calculated from the river stretch imagery for the year 2004, 2010 and 2016.

It is revealed from the analysis that in all 3 bends the sinuosity is under the safe limit during the period 2004 to 2016 although it is increasing. The Bend 1 is at comparatively at high risk. In tis regard we can conclude that few more spurs can readjust the river morphology without giving much load and impact on the right embankment. In order to check scouring at the toe of spurs stone dumping, stone pitching or vertiver grass plantation may be done.
