Impact of Climate Change on Geo-Hazards: A Case study of Uttarkashi-Bhatwari and Gangnani Area, District, Uttarkashi, Garhwal Himalaya, Uttarakhand

N.P. Naithani

Assistant Professor,
Dept. of Geology,
HNB Garhwal University Campus,
BadshahiThaul, Tehri,
Uttarakhand, India

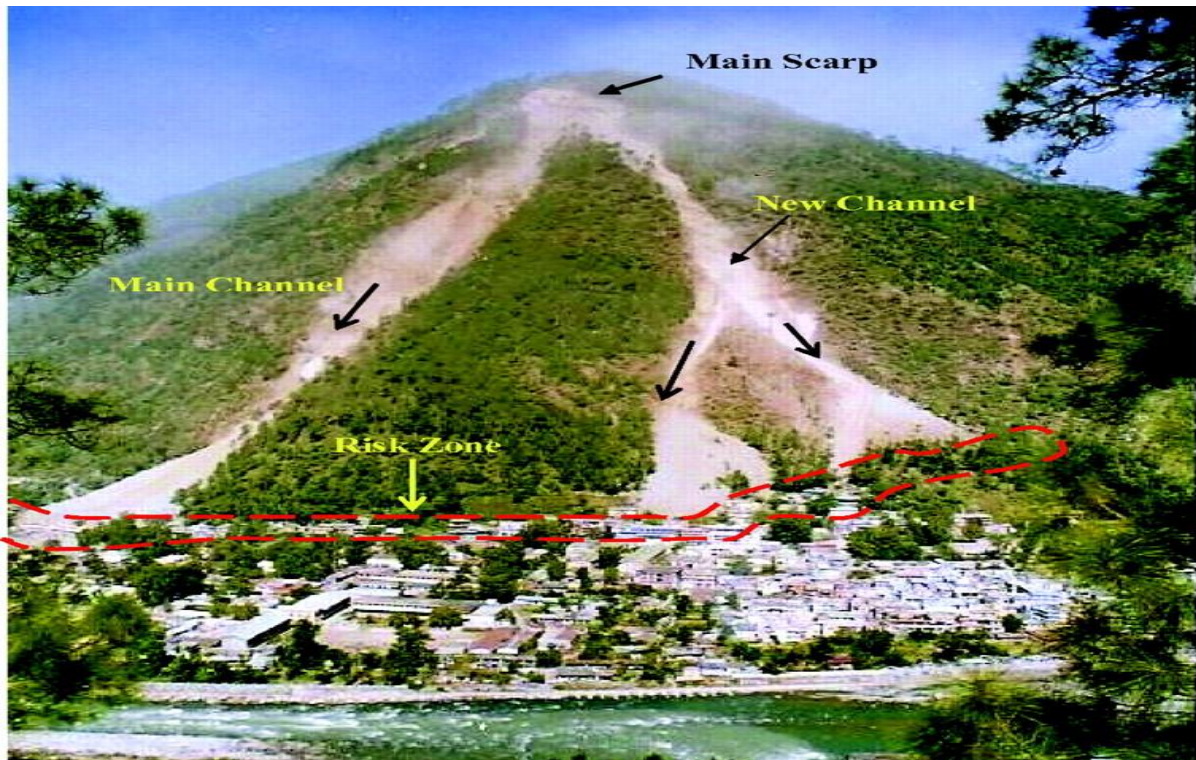
Photograph-1; Varunawat Landslide of Uttarkashi

2. Due to Uttarkashi earthquake the cracks were observed at various places over rocks, debris material and rock fall others. Varunawat landslides started in 1998 but no attention was given by Government. In the name of development and tourism the multi stories buildings were constructed by cutting the foot slope of Varunawat. On 3 August 2003 the Varunawat landslide causes the loss of property and life in Uttarkashi.

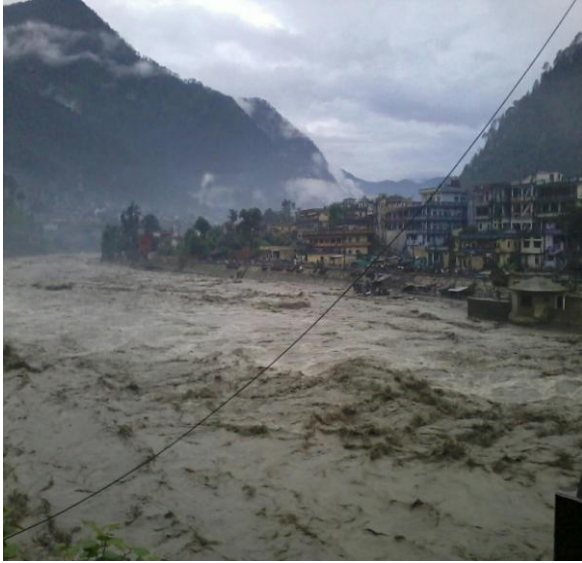
Photograph-2; Uttarkashi Flood 2012

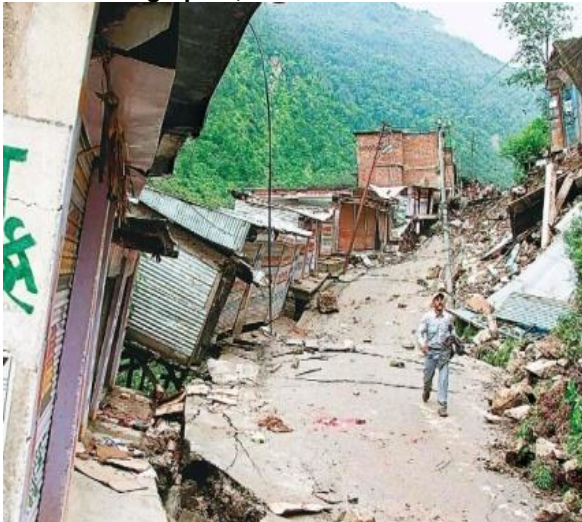
Photograph-3 ; Slumping Of Shops In Bhatwari (2013)

4. In Bhatwari and Chadethi river is flowing in a V shaped valley. These amphibolites are the rocks which are steeply dripping towards Bhagirathi River. Bhatwari market is located over debris and mylonitic migmatities. During Earthquake the cracks were observed at various places. Local people constructed multi stories hostel here it is located in the Uttarkashi Gangotri high way. In 2010 and 2012 due to toe erosion of Bhagirathi river 69 shops and residential houses slump in Bhagirathi River.

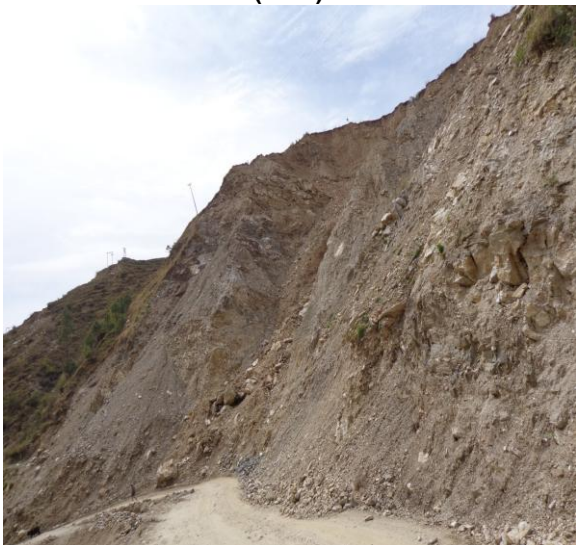
Photograph-4 ; Landslide Near Malla

3. Between Malla and Bhatwari the mylonitic migmatites are there. Roads were constructed along the Bhagriathi River. Due to toe erosion of Bhagirathi River the roads were damaged and land slide started in the upper part of road. This may block the Bhagirathi river may cause the disaster in future in the valley.

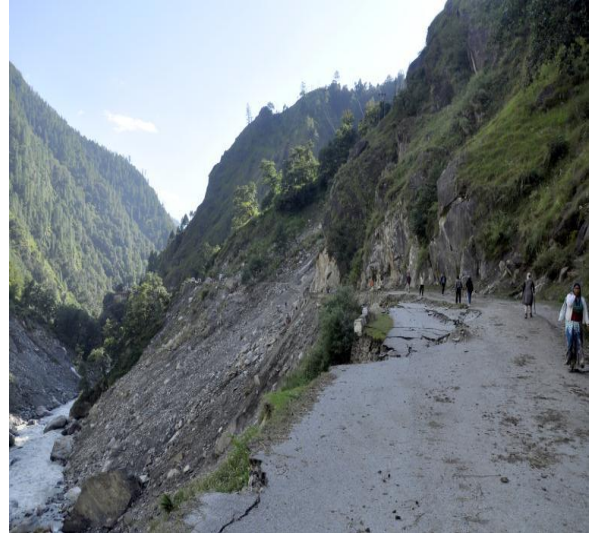
Photograph-5; Landslide Near Sunagarh(2016)

Between Malla and Bhatwari, road were subjected to the subsidence due to the toe erosion of Bhagirathi River. Landslide of Sunagrah and Gangnani are also due to toe erosion of Bhagirathi River. In the upper part of Gangnani temple new landslide reactivated which is very dangerous to Gangnani temple and hostsprings at Gangnani. Rocks in this area are highly mylonitised nature and comprises of Schists and gneisses.

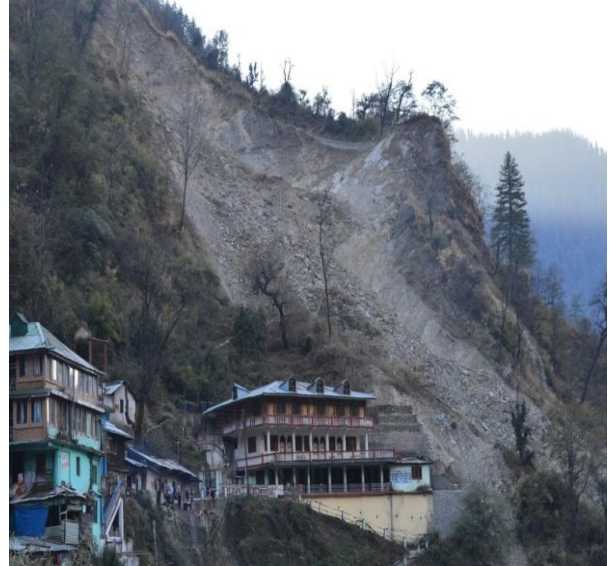
Photograph-6 ; Gangnani Landslide(2016)
