An Investigation on Shifting and Subsidence of Right Embankment of Devee River at Bauriakana, Puri District of Odisha

Gopal Prasad Roy

Anil Kumar Kar

Kabir Mohan Sethy

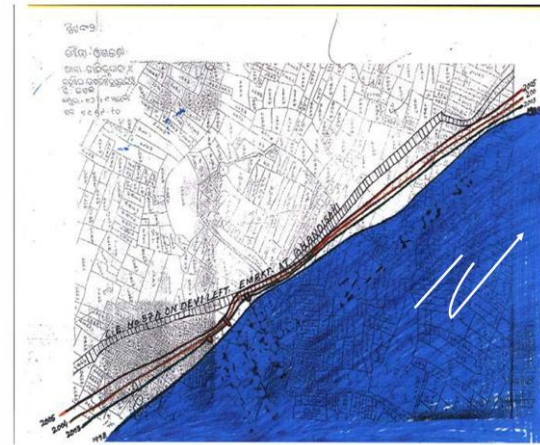
The left side also has huge agricultural land (Fig.3) justifying the locality as an agricultur based economy area. Generally the agriculture profession is labour oriented and manpower based, which develops dependency and that creates a social bonding.

Fig. No.3. Left embankment and huge agricultural land at right bank of study area

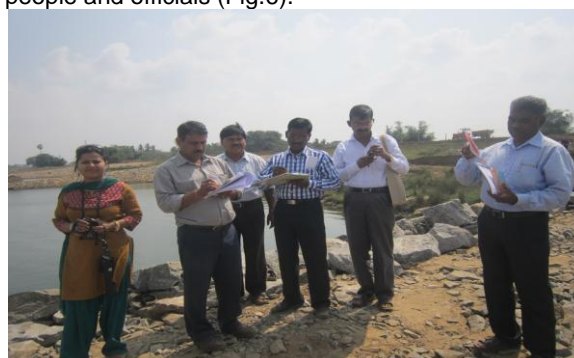
Fig.No.6. Field visit by the team to study area (Year-2015)

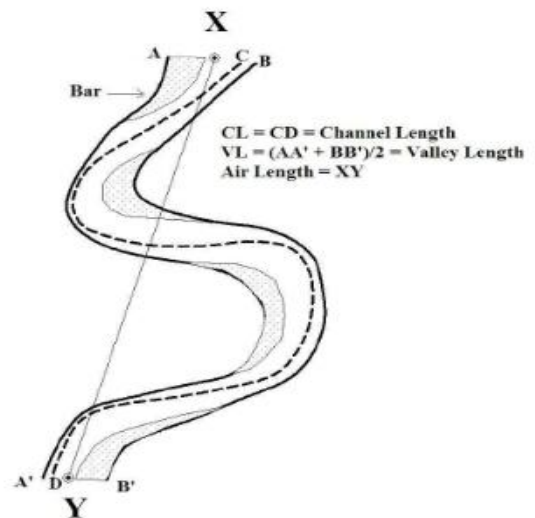
River Bank within the study area is digitized as polygons for these three years and sinuosity index (SI) are calculated. The parameters are calculated as per Mueller's Sinuosity Index (Fig.9) and its standards and limiting values of SSI are mentioned in Table 3. The SSI (Standard Sinuosity Index) is calculated as a ratio as CI / VI .

Fig.No.10. Parameters as per Mueller's Sinuosity Index
